AUTO-ORDNANCE AOM130 M1 CARBINE 30 US CARBINE, \$899

**GUN TESTS GRADE: B-**

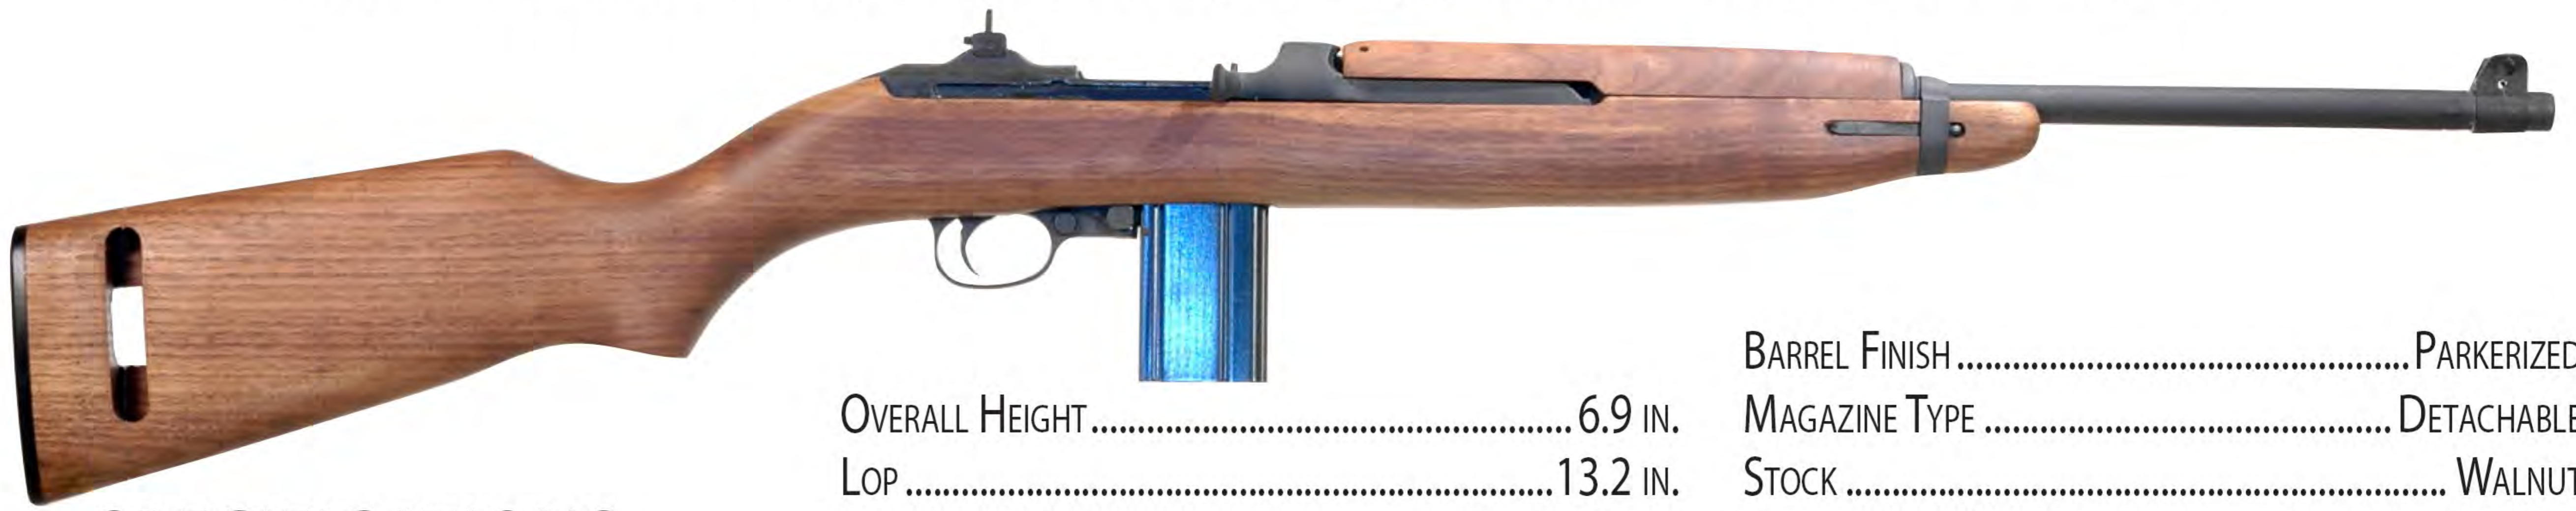
After A-O repaired the extractor, there were no more bobbles nor failures to eject. The A-O carbine delivered the finest accuracy we've encountered from an M1 carbine or clone, with five-shot groups as small as 1 inch at 50 yards. However, the trigger pull was not what we wanted.

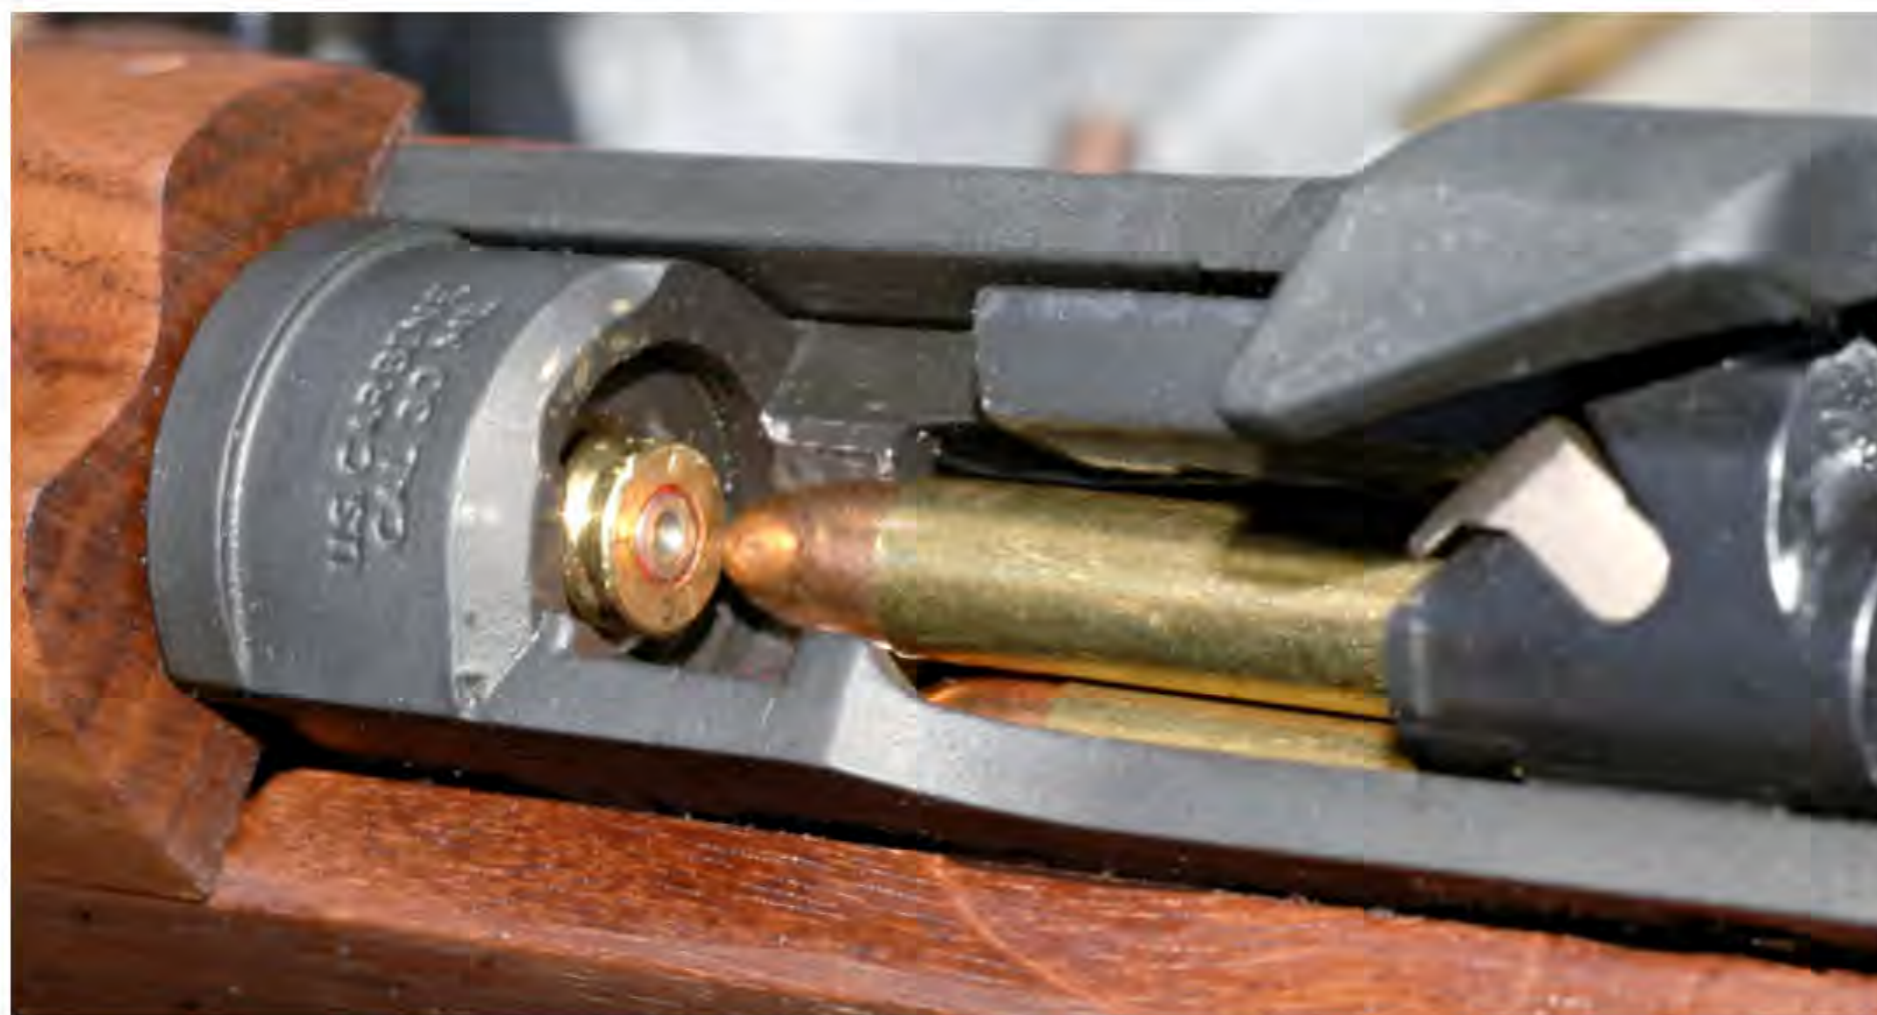
Near Right: The Auto-Ordnance gave us fits before we discovered its extractor had broken off at

the front. We got regular failures to extract and feed, such as shown here. Center: Our test Auto-Ordnance carbine broke a chunk out of its extractor early in our testing. The arrow points to the break. We sent the bolt to A-O (Kahr) and quickly got it back with a new extractor that worked perfectly.

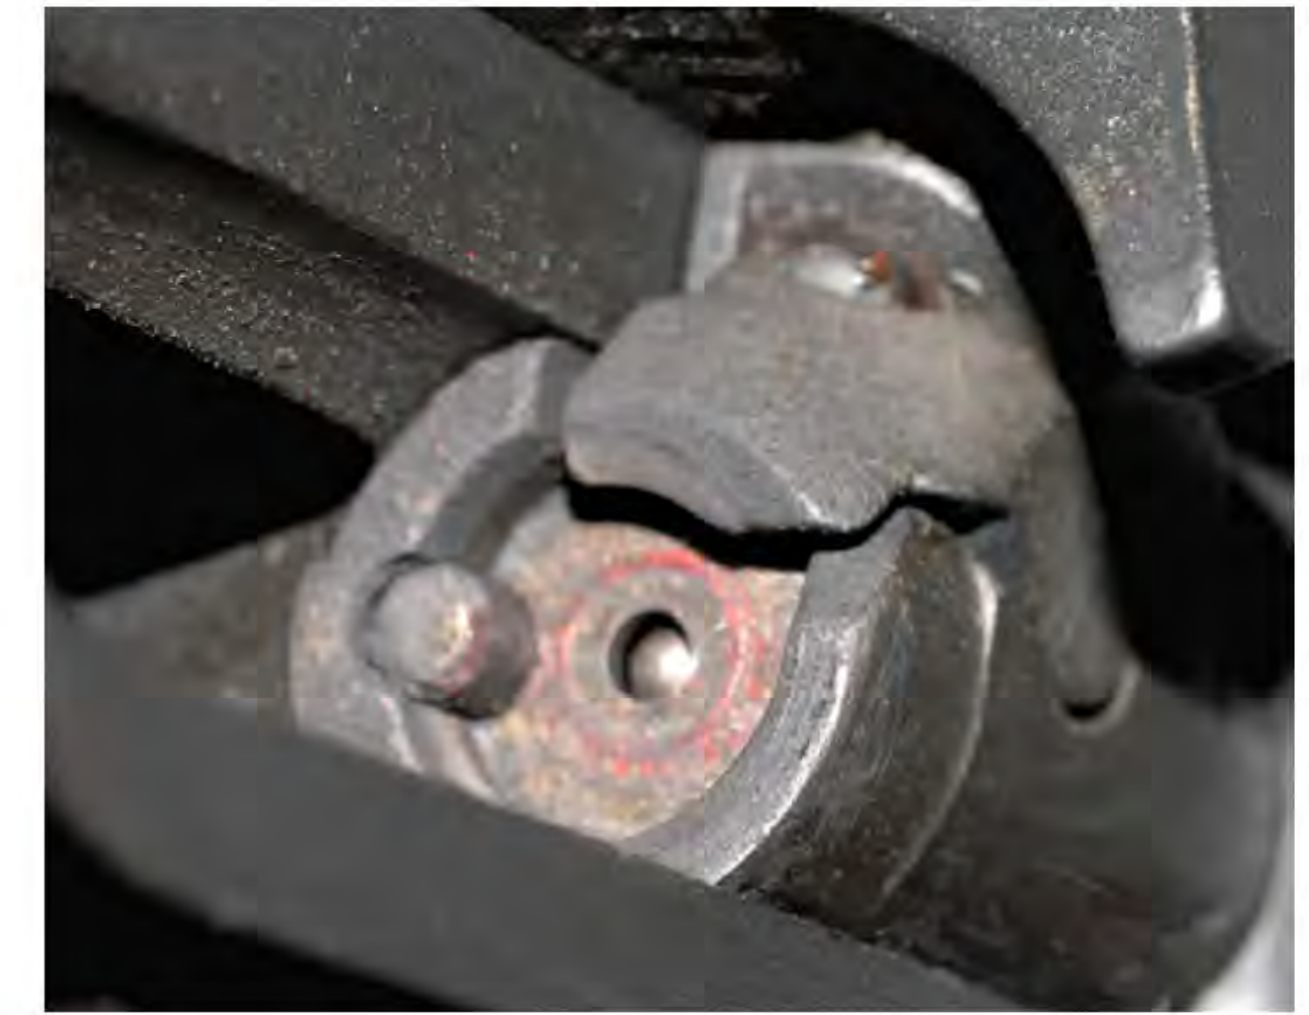
The A-O warranty would cover this, of course. Far Right: This is the undamaged extractor on the Fulton Armory carbine. It's easy to see why the A-O's unit would not get the rounds out of the chamber. Note the plunger ejector and recessed bolt head used by all carbines.

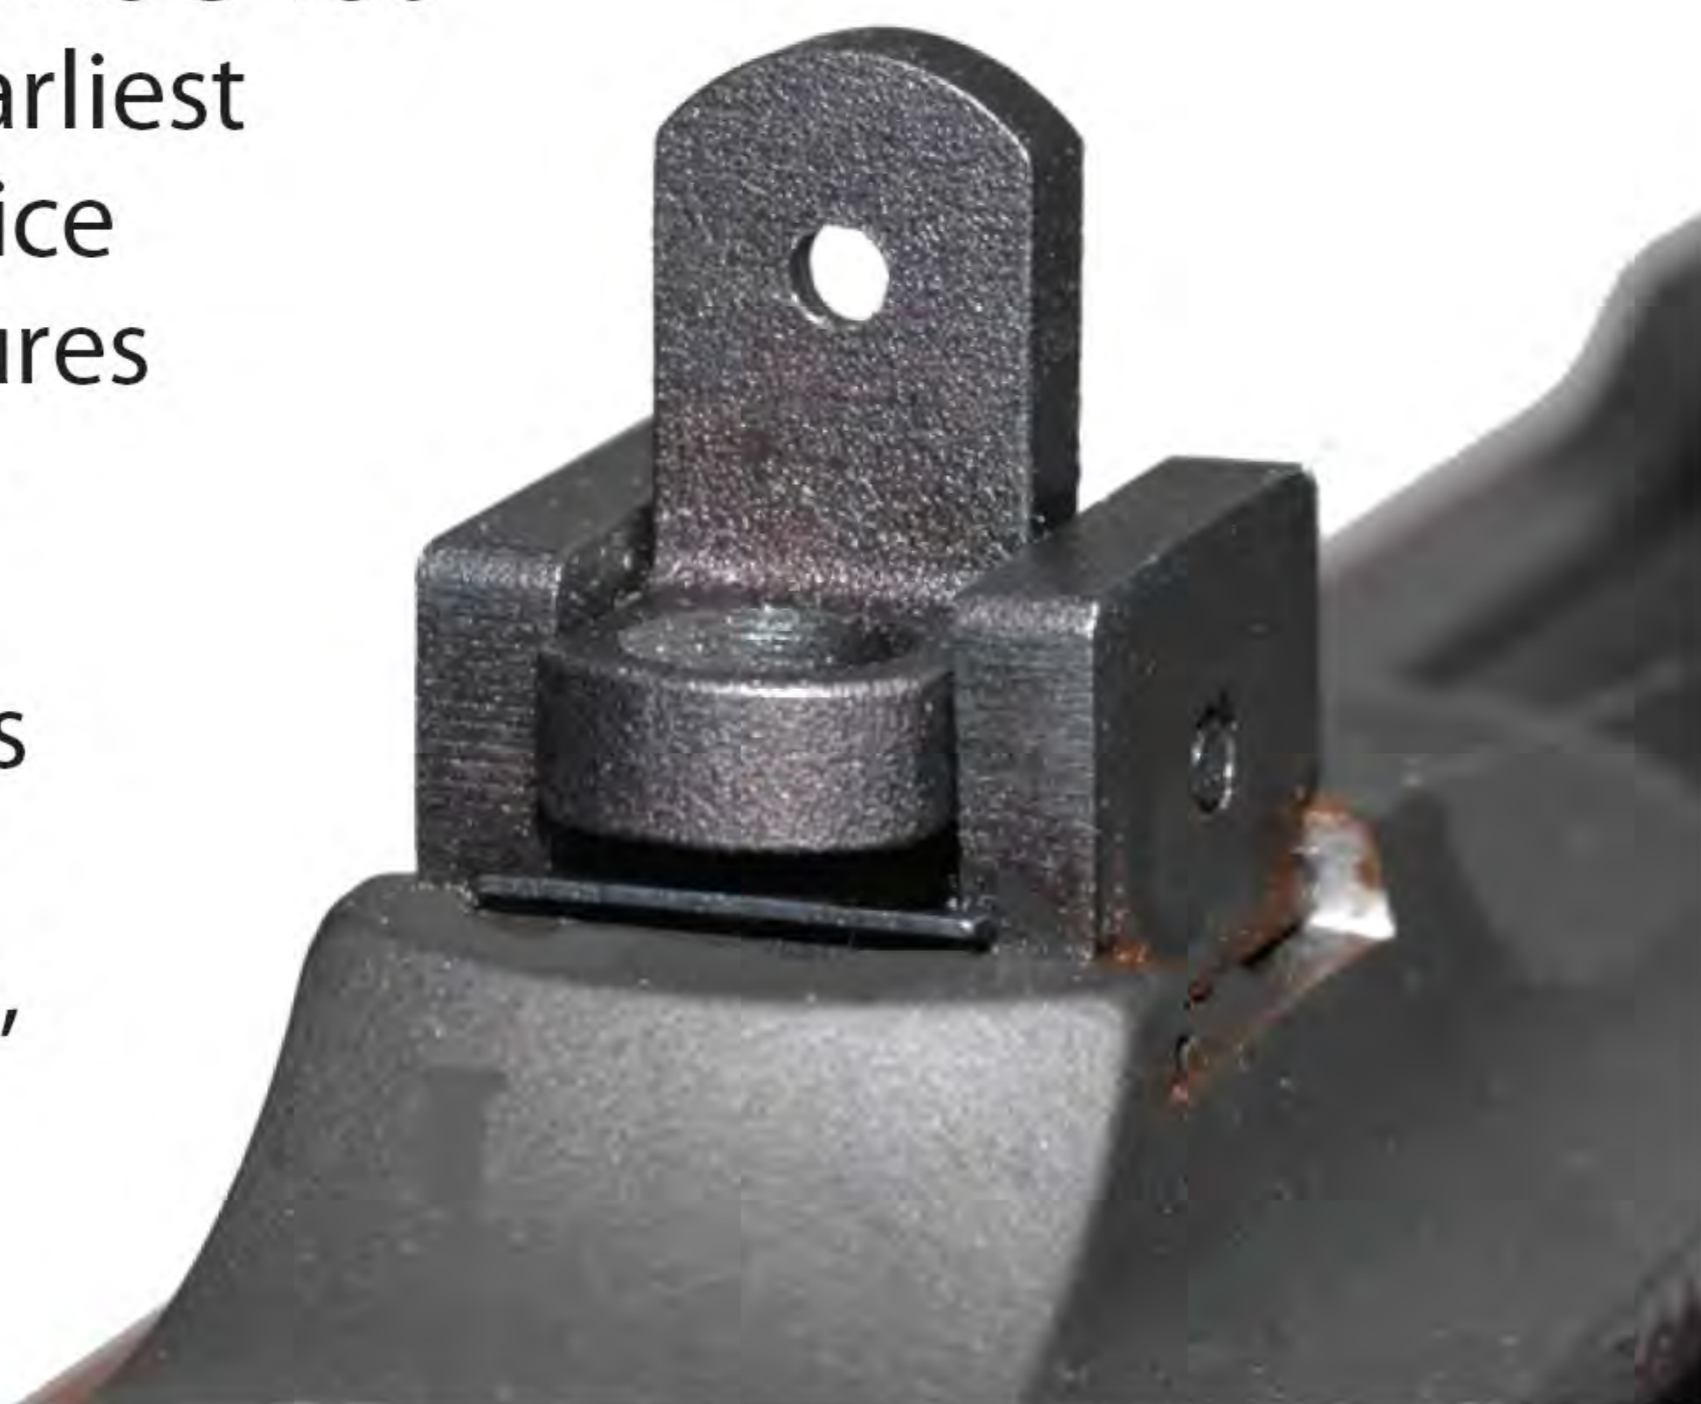
The Auto-Ordnance AOC-130 had a copy of the earliest carbine sight, a device that had two apertures at differing heights for short or longer ranges. As noted, it's only adjustable for windage by drifting, and not at all for elevation other than by selecting a different-height front-sight blade. While this is a desirable sight for collectors, the later fully adjustable one is by far better for shooters.

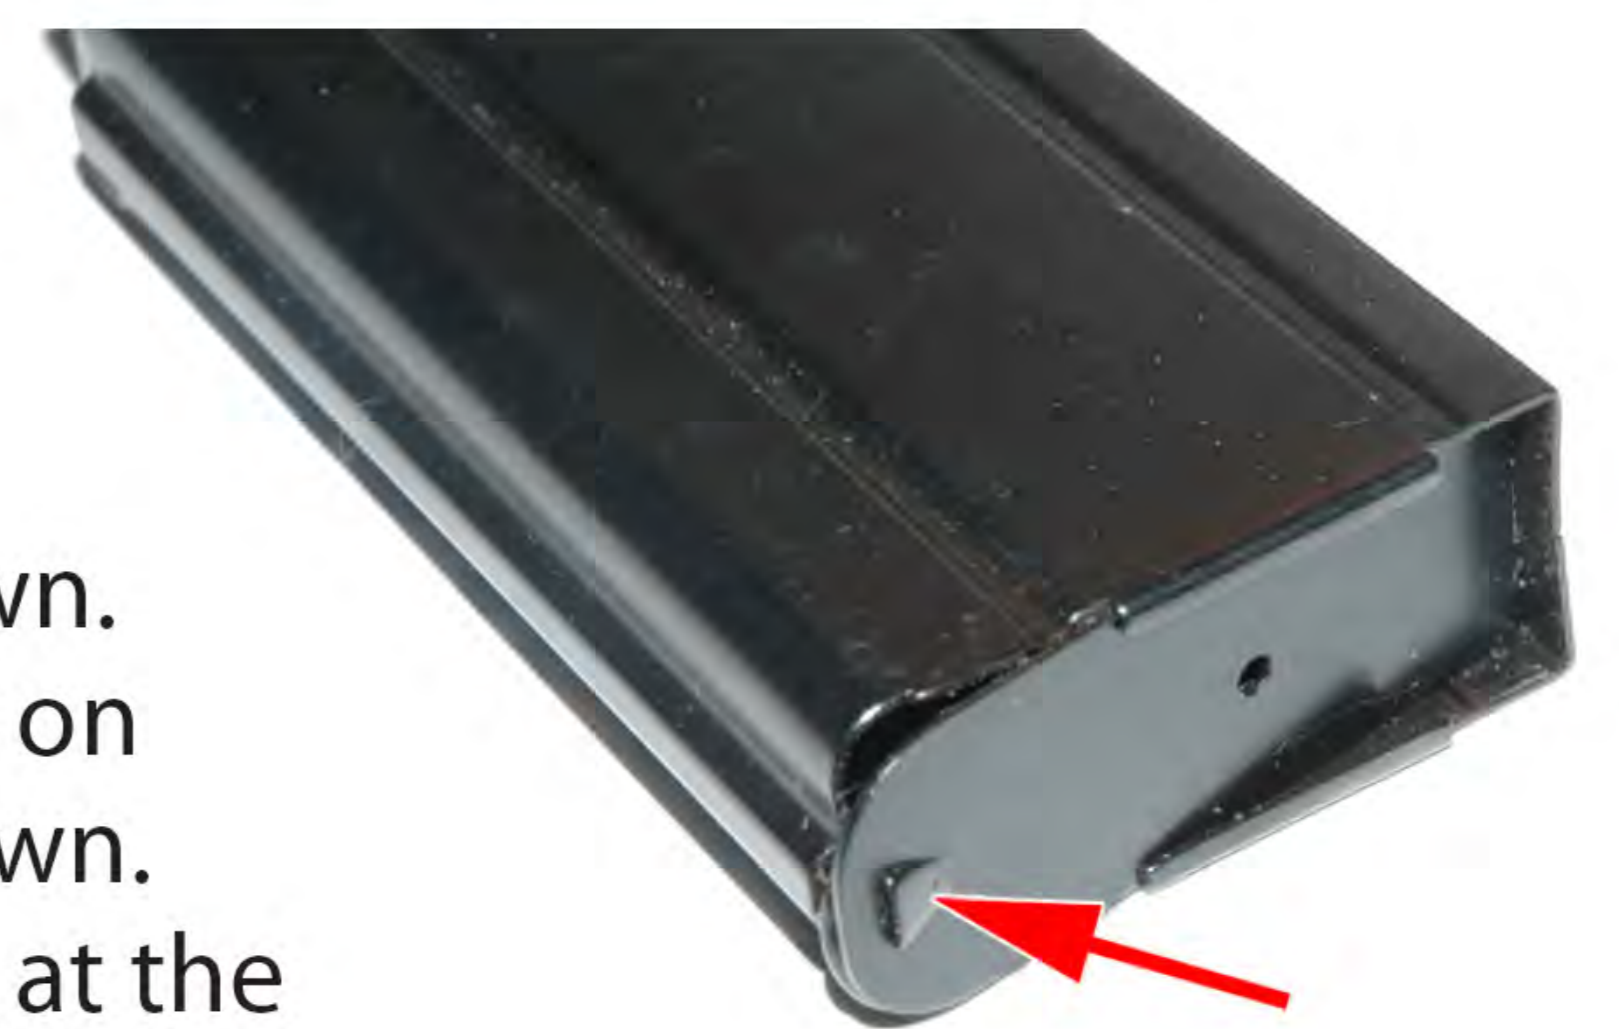
The new magazine that came with the A-O was assembled with its floorplate upside down. The little tab belongs on the inside, not as shown. Note also the poor fit at the rear of the plate. The 15-round magazine provided with the Auto-Ord by the maker was not only put together wrong, it was full of dirt. We cleaned it, put it back together correctly, and then had more jams similar to that shown. The arrow points to the rear of the magazine that ought to be filled by the cartridges shown.
